Subject: March 27, 2018 Inspection Report

**CWA COMPLIANCE EVALUATION INSPECTION REPORT
U.S. ENVIRONMENTAL PROTECTION AGENCY, REGION 5**

Compliance Evaluation Inspection

Ex. 6 (Personal Privacy) Farm

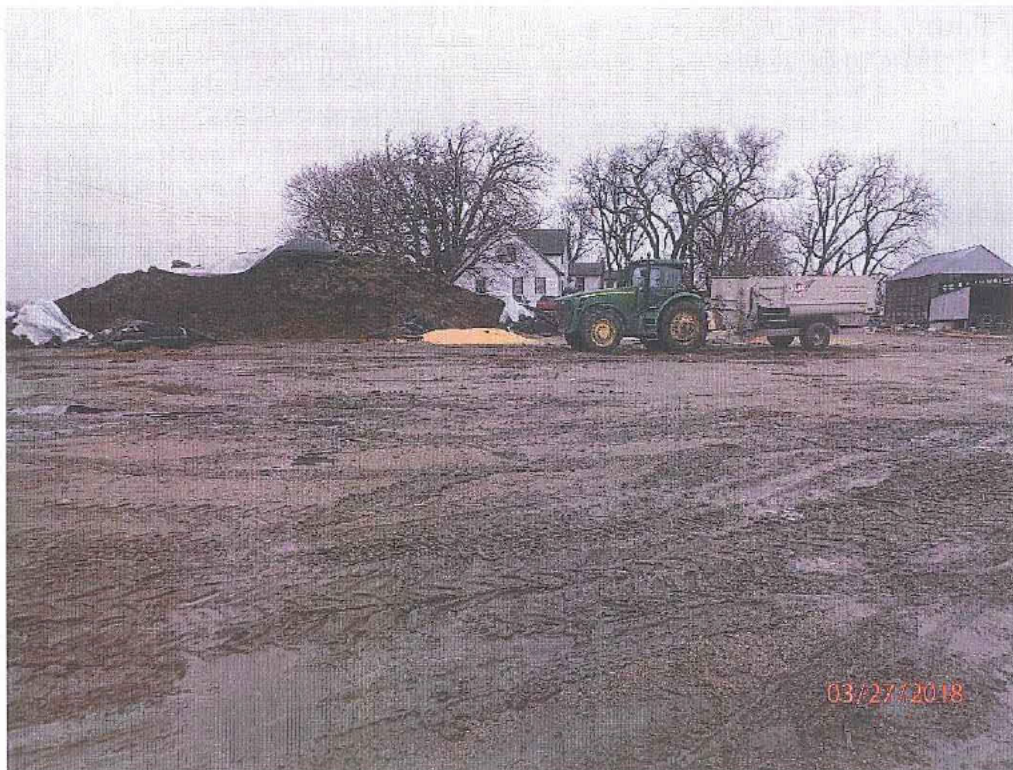
1: P3270017

EPA began the walk through of the Ex. 6 (Personal Privacy) on the west side where the haylage is stored. The haylage is covered and EPA observed a small amount of feed on the ground in front of the pile. There was also gluten and dry corn stored on the ground in front of the haylage. The facility owner stated that in the summer he intended to build another bay onto the Commodity Barn and move the gluten and dry corn to that bay. It will then be under roof and protected from the precipitation.

Description: Haylage is kept covered except for a small amount of gluten and dry corn, which will be moved to a new location in the summer. The new location will have a roof.

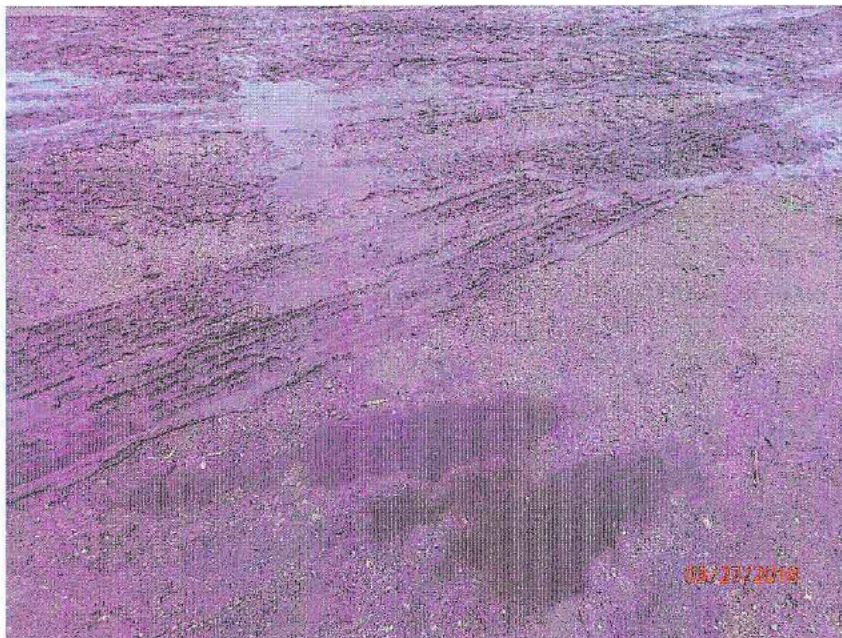
2: P3270018

Description: Leachate from the haylage and feed flows over the ground to the south.

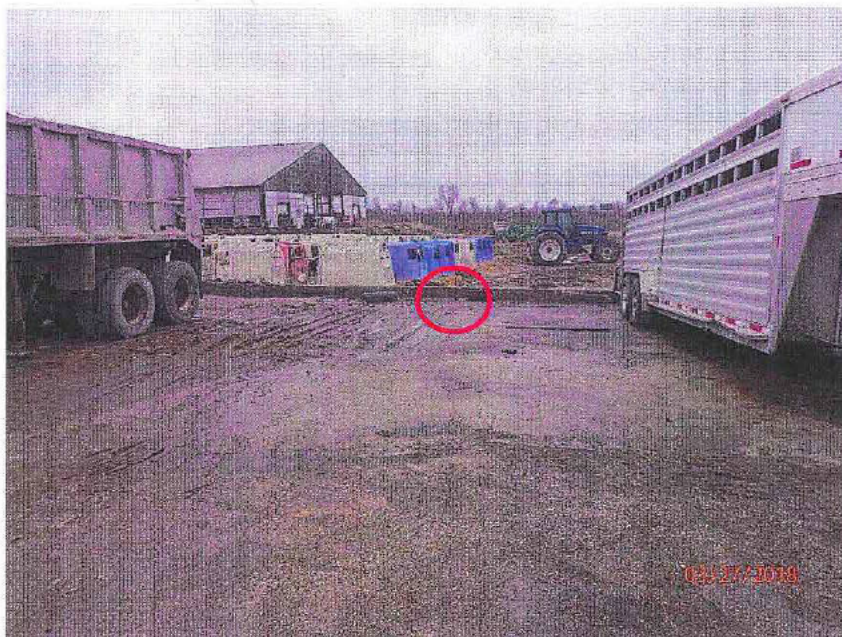
3: P3270019

EPA observed that the leachate from the feed stored in this area would flow south toward a concrete wall where it could flow through weep holes in the wall. On the south side of the wall, the flow pathway was to the south in front of the calf hutches. It ended up in a depression in the yard that allowed the storm water and any process wastewater from the feed to infiltrate into the ground. There was no water in the depression area and a dirt berm kept additional storm water from surrounding areas from going into the depression and would keep any process wastewater in the depression from flowing out to a surface water.

Description: Looking south from haylage, any leachate would flow to the south and then through weep holes in concrete wall. Red circle denotes location of a weep hole.

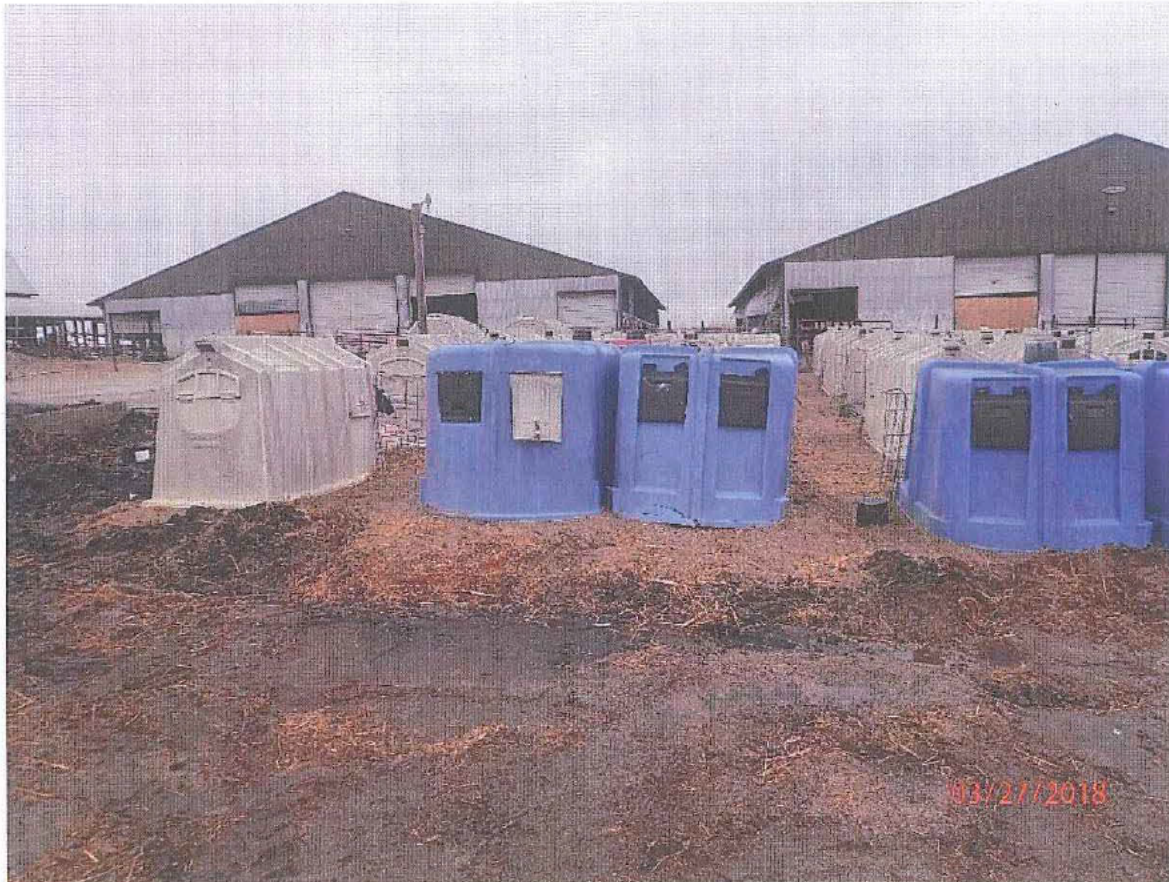
4: P3270020

The calf hutch pad has been raised by one foot and there are two less rows on the south side and one less on the west side. This was done to keep the calf hutches out of the depression area. Process wastewater from the calf hutches would infiltrate into the new pad but any runoff would also flow to the depression area. EPA did not observe any runoff from the calf hutches on the day of the inspection.

Description: Calf hutch pad has been raised with a foot of gravel to allow for infiltration of leachate from calf hutches. Haylage and feed leachate, after flowing through weep holes, flows south in front of calf hutches and to a low depressional area south and west of the calf hutch area.

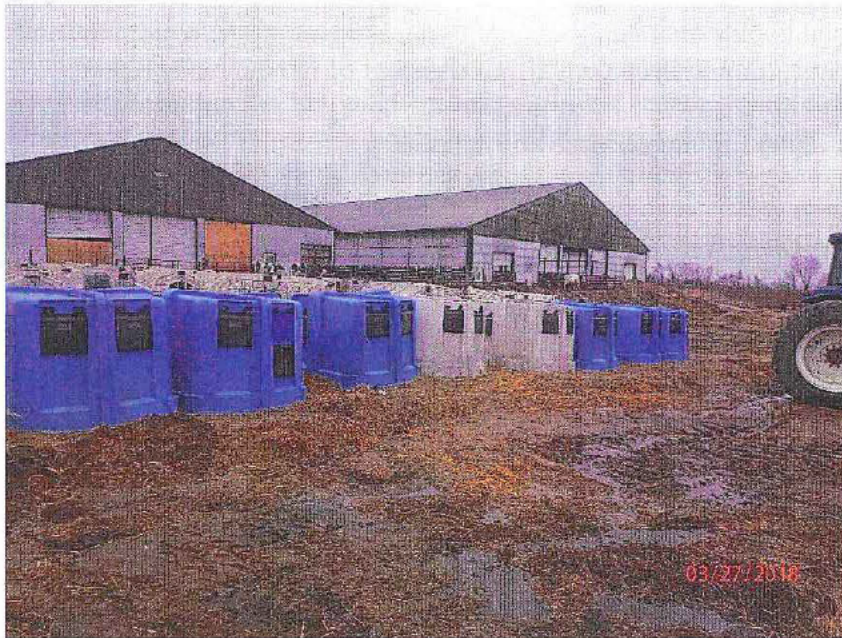
5: P3270021

Description: Calf hutch area is raised a foot and there are fewer rows.

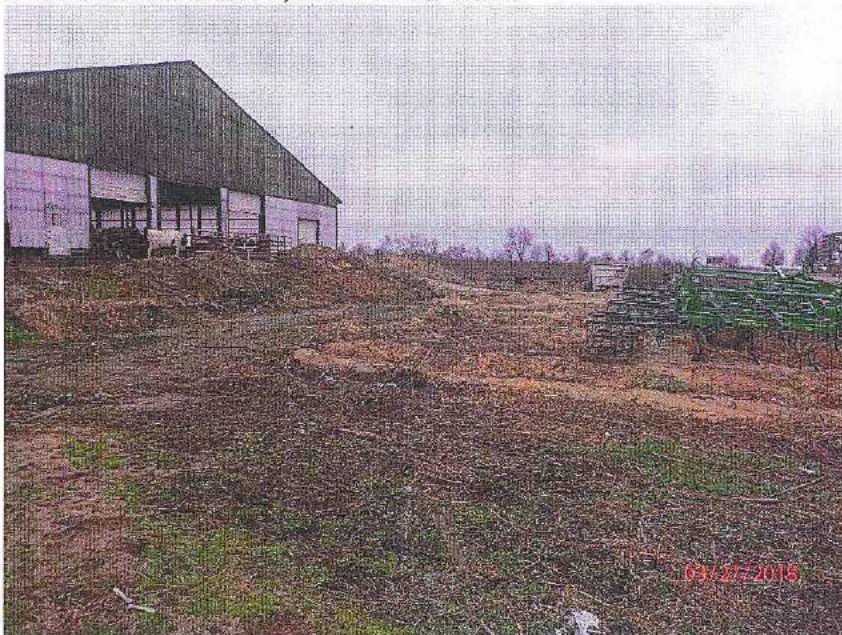
6: P3270022

Description: Depressional area south and west of the calf hutches is in the foreground and it holds any leachate runoff from hutches and feed. A dirt berm prevents the flow from reaching surface water.

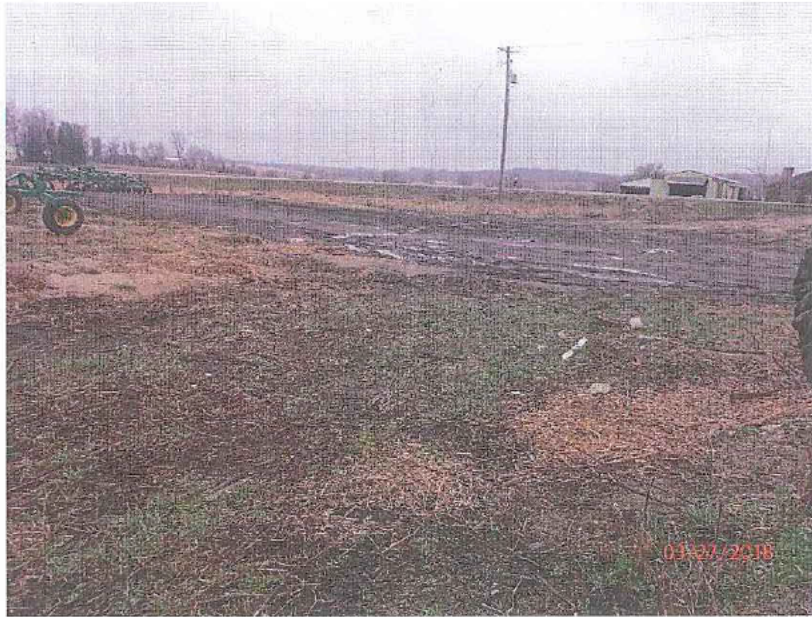
7: P3270023

Description: Depressional area south and west of the calf hutches holds any leachate runoff from hutches and haylage and feed. A dirt berm prevents the flow from reaching surface water.

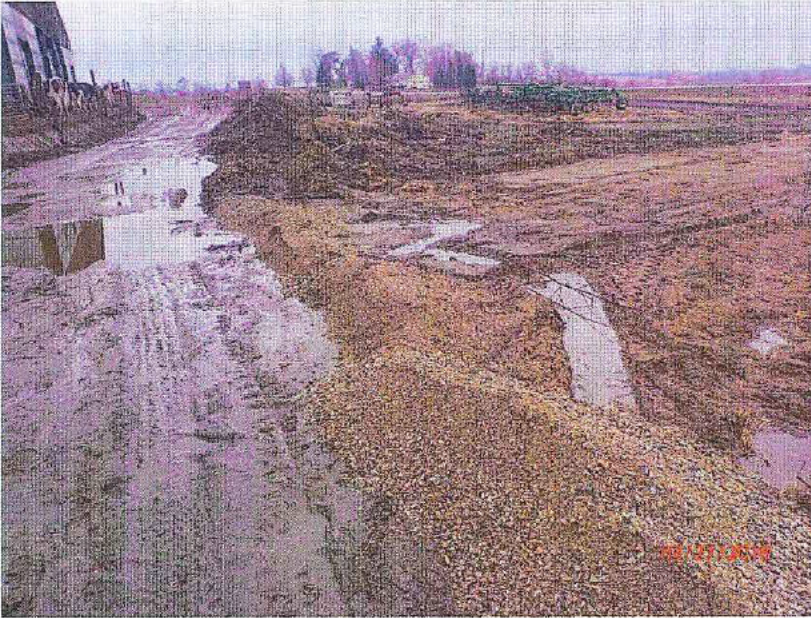
8: P3270024

Description: Sand and dirt berm along facility driveway prevents precipitation from flowing into the depressional area south and west of the calf hutch area and directs the precipitation to a storm water channel.

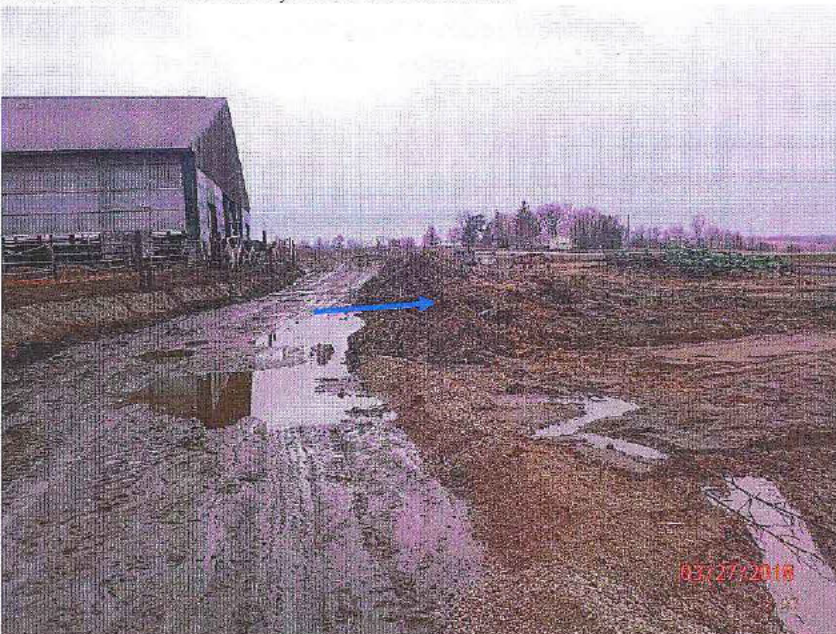
9: P3270025

Description: Sand and gravel berm directs storm water to a storm water channel. Blue arrow denotes location of a storm water channel.

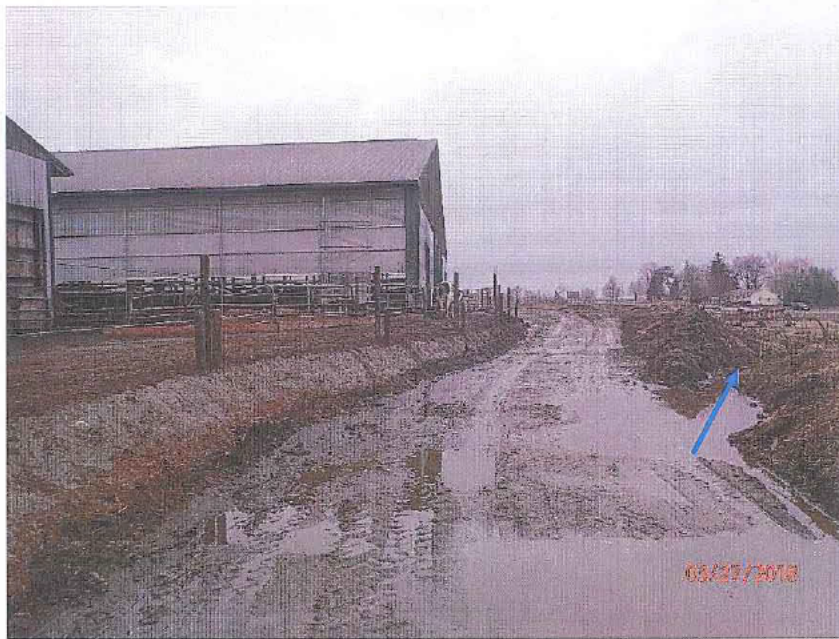
10: P3270026

Storm water from the roofs of the Freestall Barns was piped from between the barns, under the Cattle Walkway to the west and to the facility driveway on the west side of the Freestall Barns. The flow of water was then down the driveway to the south until the lowest point in the driveway. At that location, there was a storm water channel that led to the ditch on the south side of the facility.

Description: Storm water flow enters the storm water channel on the west side of the facility driveway. Blue arrow denotes location of storm water channel.

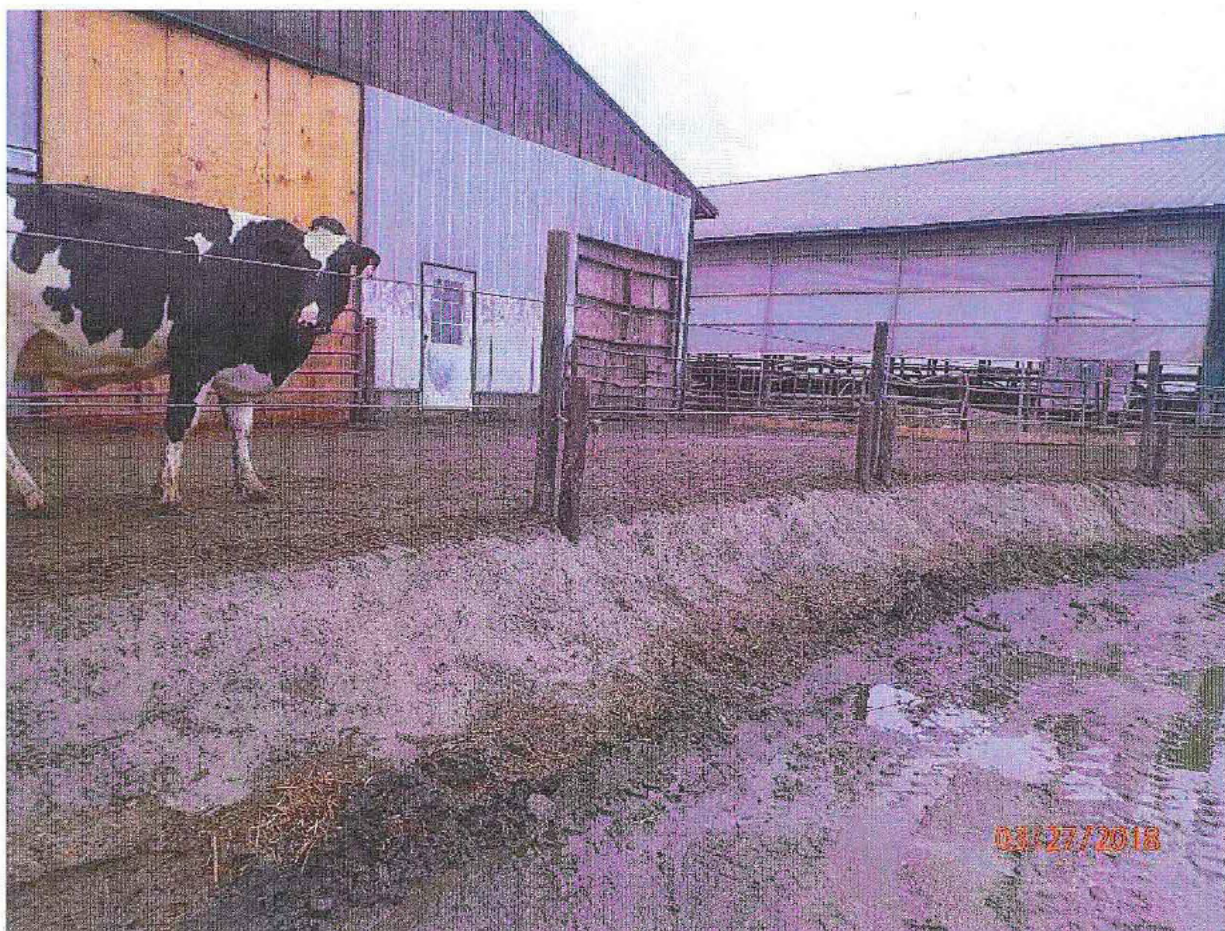
11: P3270027

4. The measure to prevent manure and process wastewater from dropping onto the facility driveway and then being transported to the Storm Water Channel from the Cattle Walkway consists of a dirt berm at the lip. The dirt berm is an interim measure and without constant upkeep, it could fail and allow manure

and process wastewater from the Cattle Walkway to flow to the Storm Water Channel.

Description: Cattle Walkway has been concreted and built up so that the process wastewater flows back into the barn and then to the manure pond. A small dirt berm on the edge of the concrete does not appear to contain all the manure from the walkway, though. Owner intends to put a concrete berm at the edge of the concrete.

The facility owner uses dirt to create a lip on the edge of the concrete to prevent manure and process wastewater from being pushed over the edge of the concrete. EPA observed bedding pushed off the walkway and discussed the possibility of a more permanent lip at the edge of the concrete with the facility owner. The facility owner stated that he intended to install a concrete lip at the edge of the concrete walkway this year.

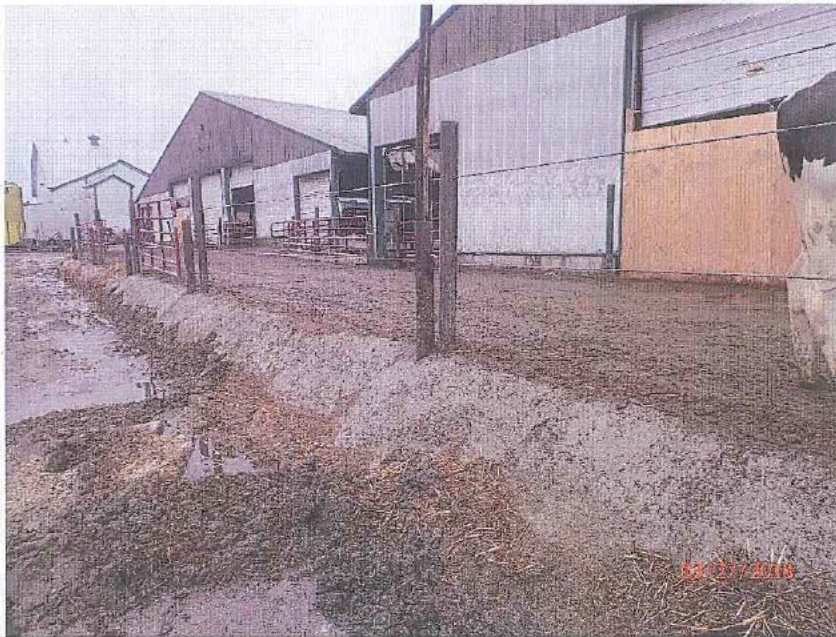
12: P3270028

Description: Dirt berm at edge of concrete does not appear to contain all the manure and bedding from being pushed onto the facility driveway.

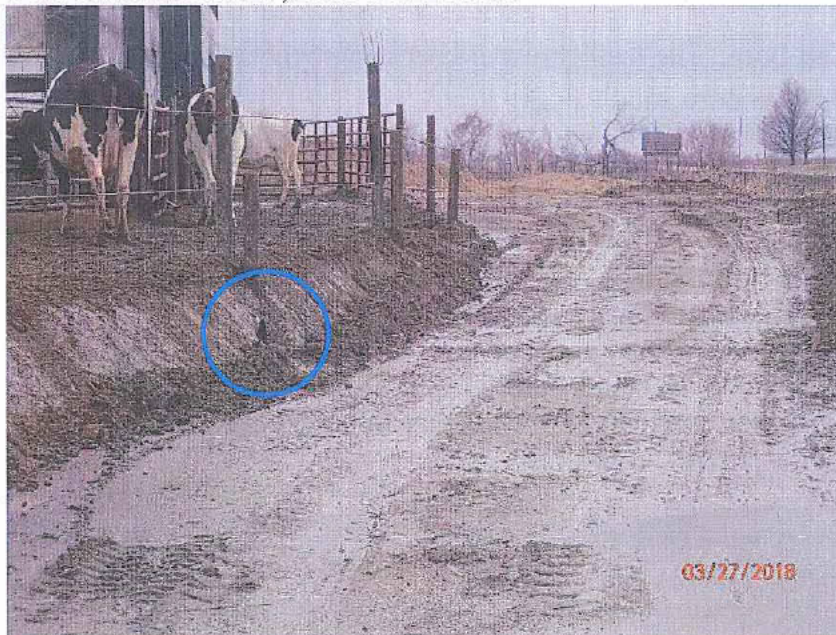
13: P3270029

Description: Blue circle denotes outlet of storm water pipe from roof water that drops between barns.

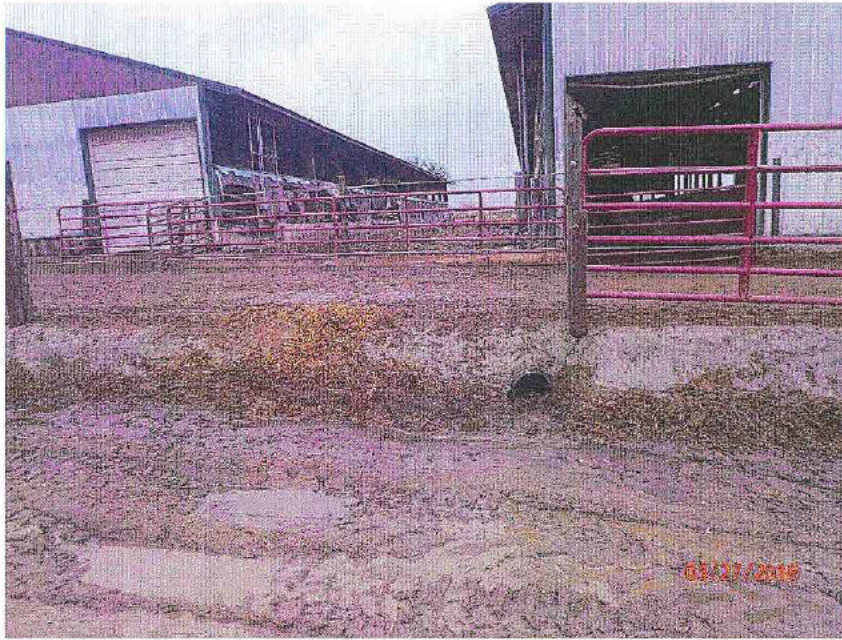
14: P3270030

Description: Roof storm water flows to the east through a pipe under Cattle Walkway then over facility driveway and to the storm water channel.

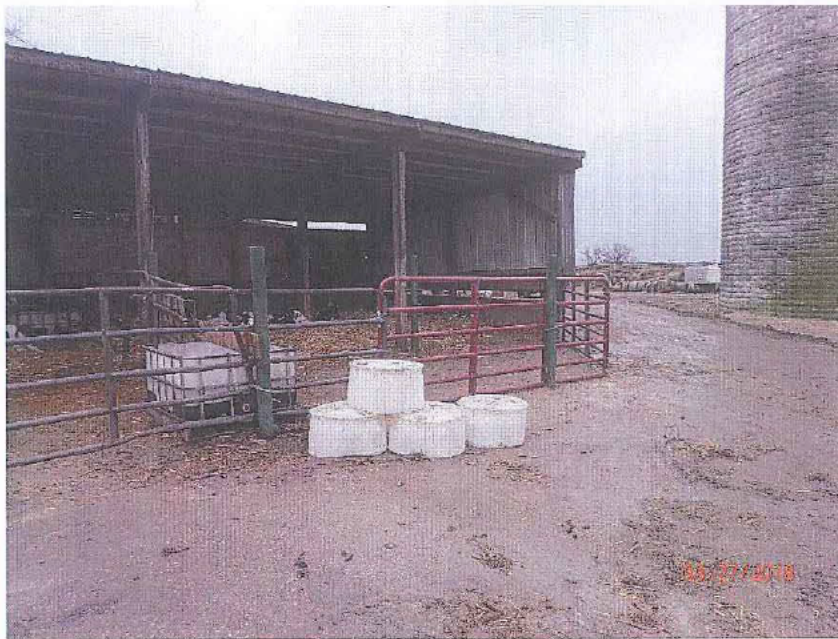
15: P3270031

1. The manure and process wastewater from the Calf Barn is not contained and has the potential to reach the Storm Water Channel to the south.
2. The measures to divert manure and process wastewater from the Calving Pen to the east and to the Old Manure Pond consists partially of a gravel berm. The gravel berm is an interim measure and without constant upkeep, it could fail and allow manure and process wastewater from the Calving Pen to flow to the Storm Water Channel to the south.

EPA then walked north to the Calf Barn. The facility owner keeps approximately a dozen calves in this barn and they are bedded with straw. An open pen of the Calf Barn had no containment for process wastewater. The process wastewater could flow with precipitation to the south and then along the driveway to the storm water channel west of the Freestall Barns. EPA did not observe a discharge on the day of the inspection.

Description: Calf Barn feed is kept pushed back under roof. Leachate would flow to the south.

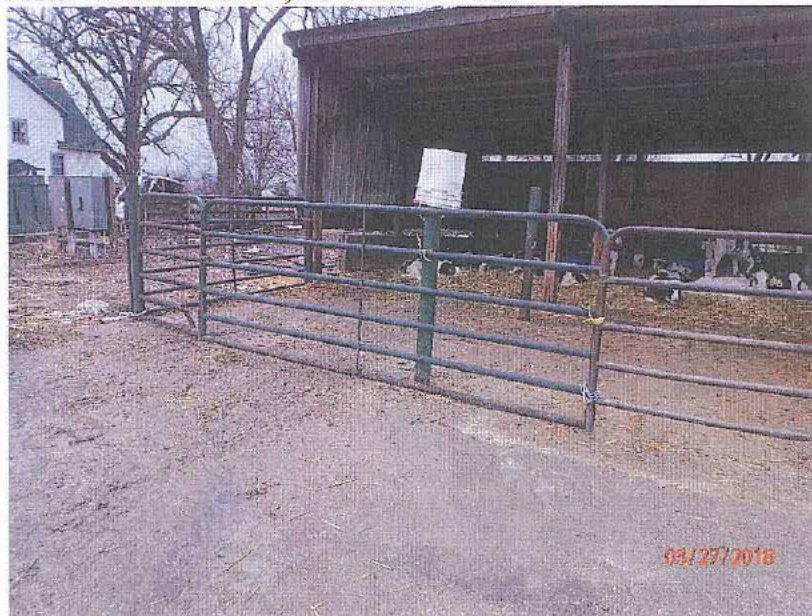
16: P3270032

Description: Small amount of calves kept in this barn. Straw is kept pushed back under roof but leachate would flow to the south.

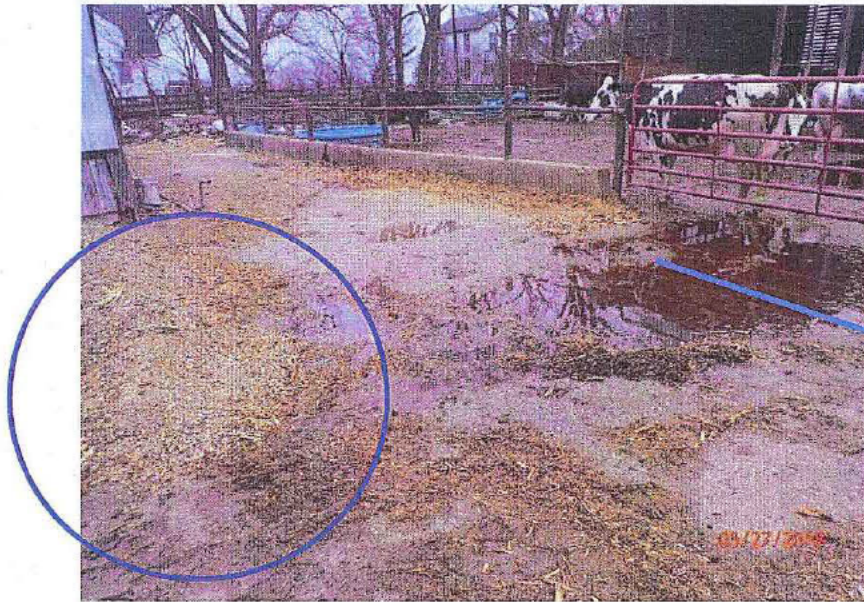
17: P3270033

EPA then walked north to the Calving Pen. Previously, the process wastewater from this pen would also flow to the south and to the storm water channel. But now, there was a gravel and dirt pile and a small hump in the concrete in front of the pen that directed the flow along the ground to the east and then to the south to the manure pond. EPA observed the very shallow flow pathway to the east in front of the Commodity Barn which would then flow to the Old Manure Pond.

Description: Calving Pen has had concrete installed in front to direct precipitation to the east to the manure pond. Additionally, gravel is kept piled to the south to also direct flow to the manure pond. Blue circle denotes gravel pile and blue arrow denotes flow direction. See also next photo.

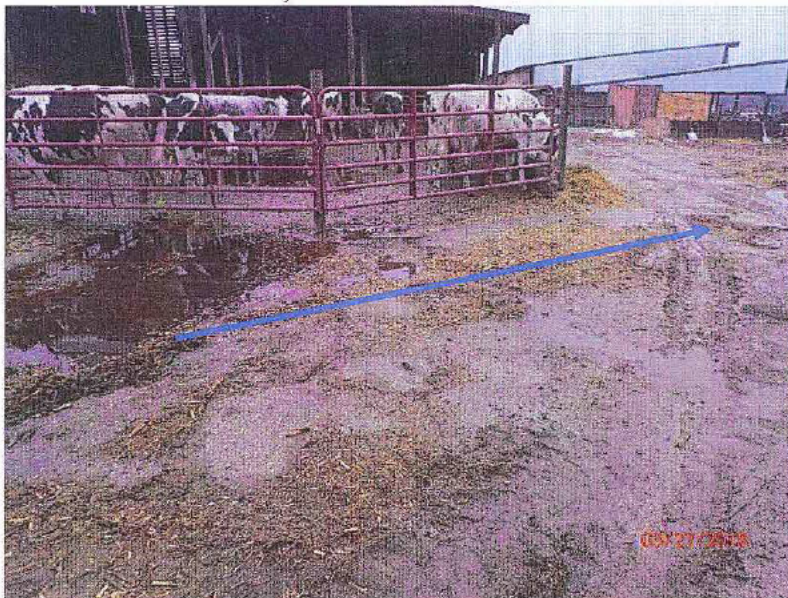
18: P3270034

Description: Although process wastewater leaves the pen to the south, the flow is then to the east, along the ground, to manure pond. Blue arrow denotes flow direction. See continuation of flow in next photo.

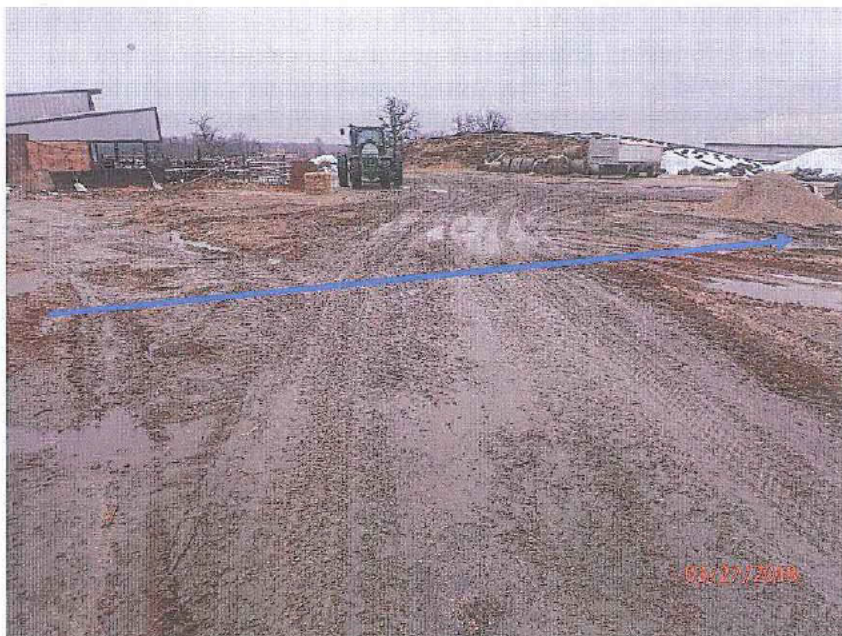
19: P3270035

Description: Continuation of process wastewater flow from Calving Pen. See also next photo.

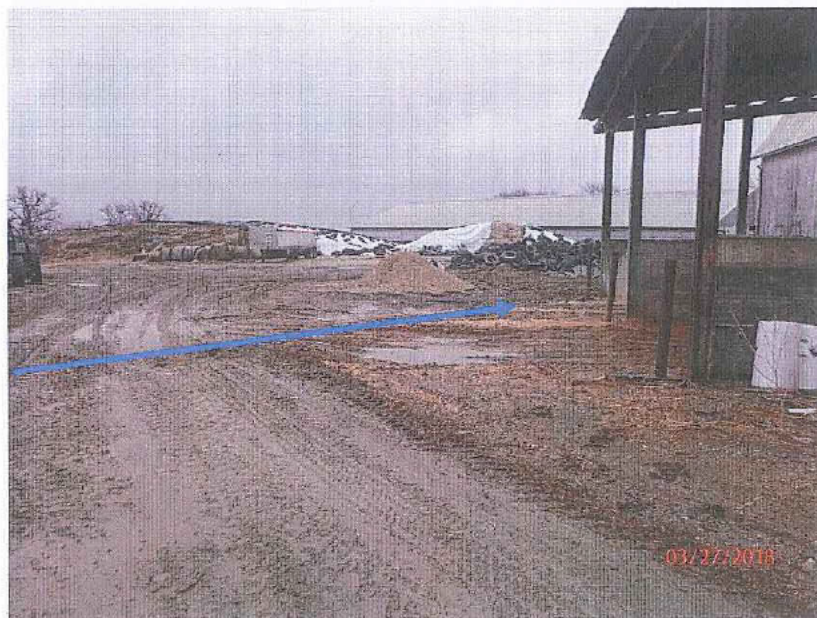
20: P3270036

Description: Continuation of process wastewater flow from the Calving Pen to the east to the manure pond. Commodity Barn is on the right of the photo.

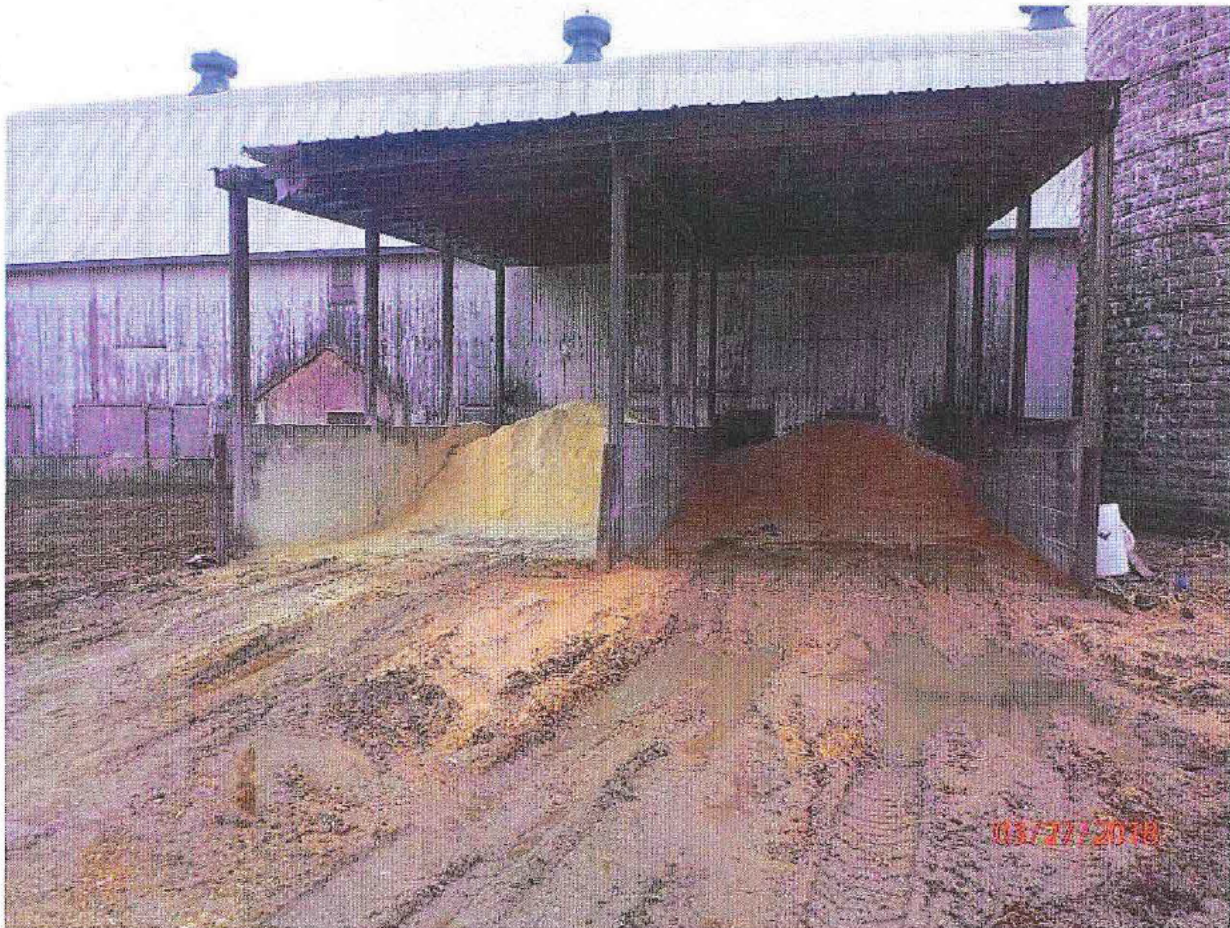
21: P3270037

The Commodity Barn is north of the Milking Parlor with the open end of the bays facing north. The facility owner stated that he intends to install another bay next to the existing two and will move the gluten and dry corn from the front of the facility to the new bay. EPA observed some product in front of the bays, but the topography of the land would direct the flow of precipitation and process wastewater to the east and then to the south to the Old Manure Pond.

Description: Commodity Barn is covered. Process wastewater from track in and track out would flow to the north and then east to the manure pond. Owner intends to add another bay to the east for the gluten and dry corn that are currently stored by the haylage.

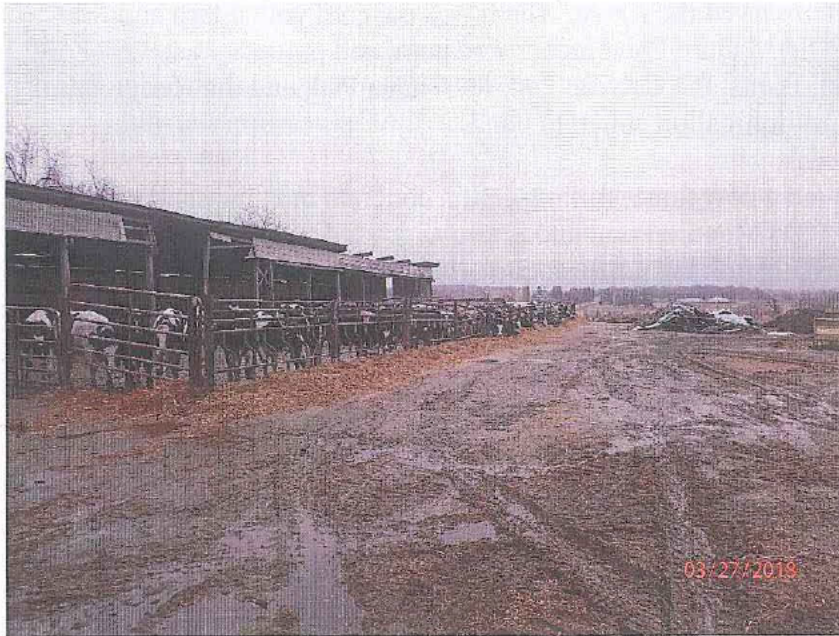
22: P3270038

Description: Feed is kept pushed up against fence of the pen for the Heifer Barn. Process wastewater from the barn and pen flows to the southeast to the manure pond.

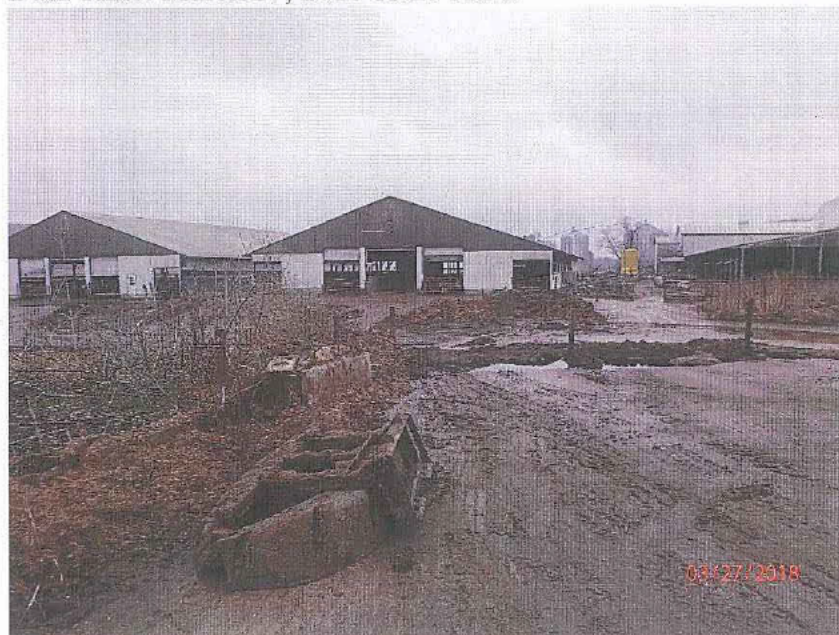
23: P3270039

Description: Flow from the east side of 2000, 2002, and 2004 Freestall Barns and west side of 2010 Freestall Barn flows to the Old Manure Pond.

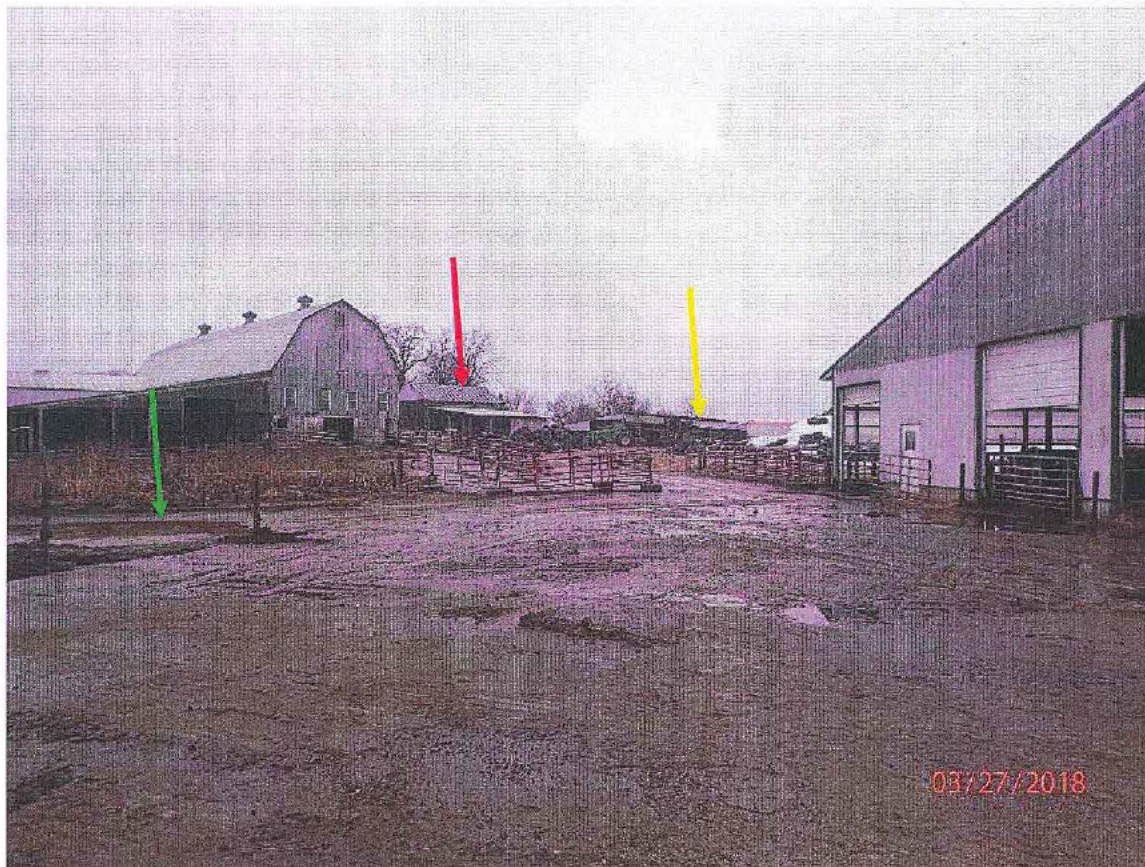
24: P3270040

Description: Calving Pen and Heifer Barns in background and 2010 Freestall Barn on right. All process wastewater flows to the Old Manure Pond, the edge of which can be seen on left side of photo. Calving Pen identified with a red arrow. Heifer Barn identified with a yellow arrow. Edge of Old Manure Pond identified with a green arrow.

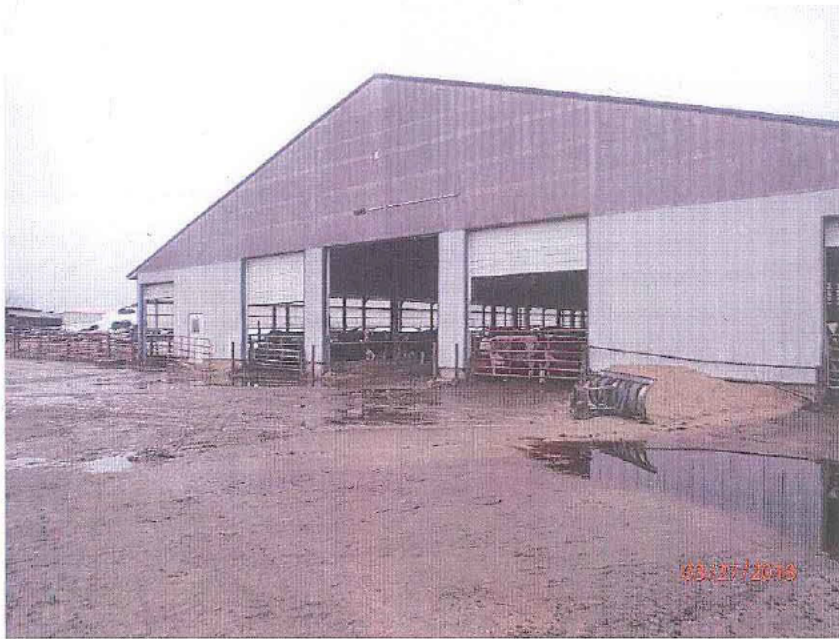
25: P3270041

Description: West side of 2010 Freestall Barn. Process wastewater flows to Old Manure Pond.

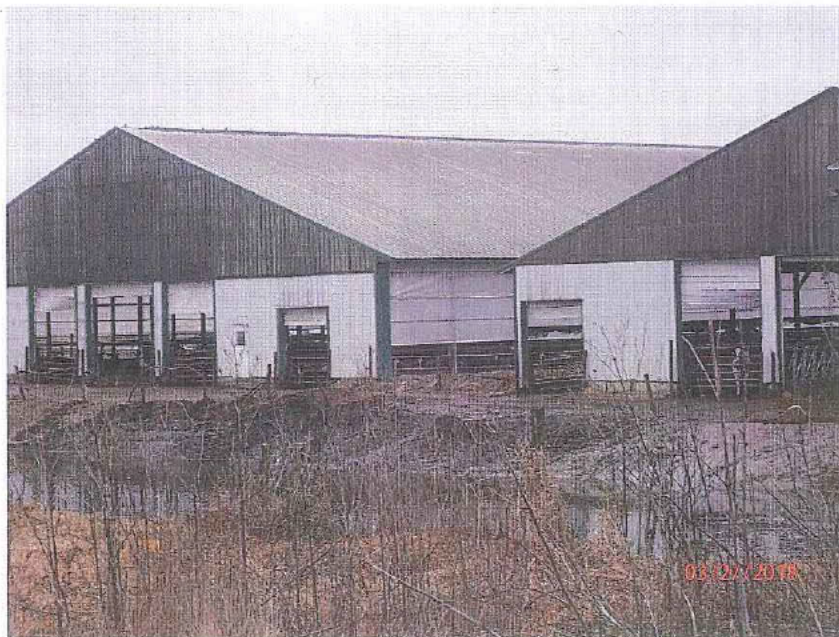
26: P3270042

Description: Close up of east doors of 2000 and 2002 Freestall Barns and Old Manure Pond in foreground.

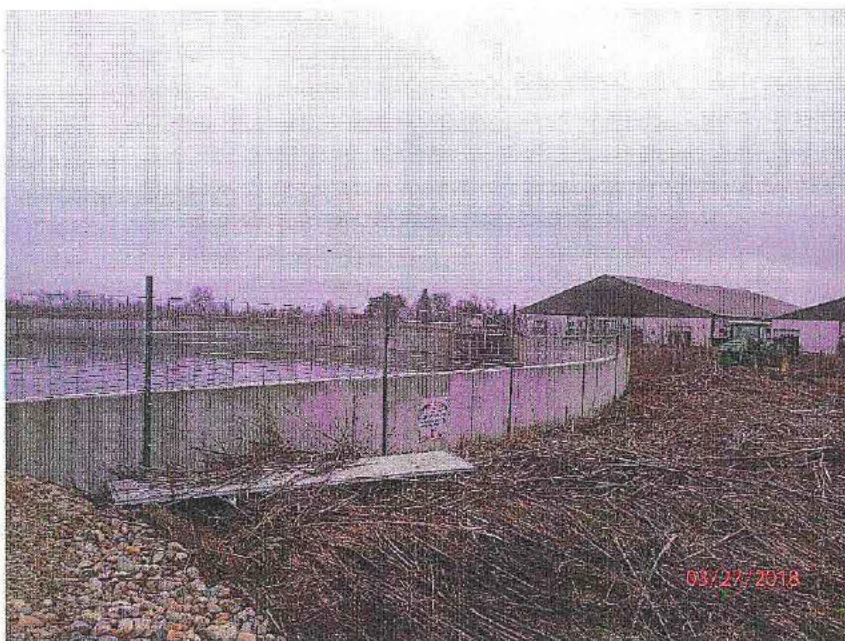
27: P3270043

In 2017, the facility owner installed a new three-million-gallon concrete manure pond. This pond is directly to the east of the Old Manure Pond and is above ground ten feet deep. Four feet is above ground and a ramp is installed on the north side to allow for the land application equipment to access the contents of the pond. The New Manure Pond has a safety fence around it and a Margin of Safety one-foot marker installed on the inside wall.

Description: New three million gallon concrete manure pond and safety fencing.

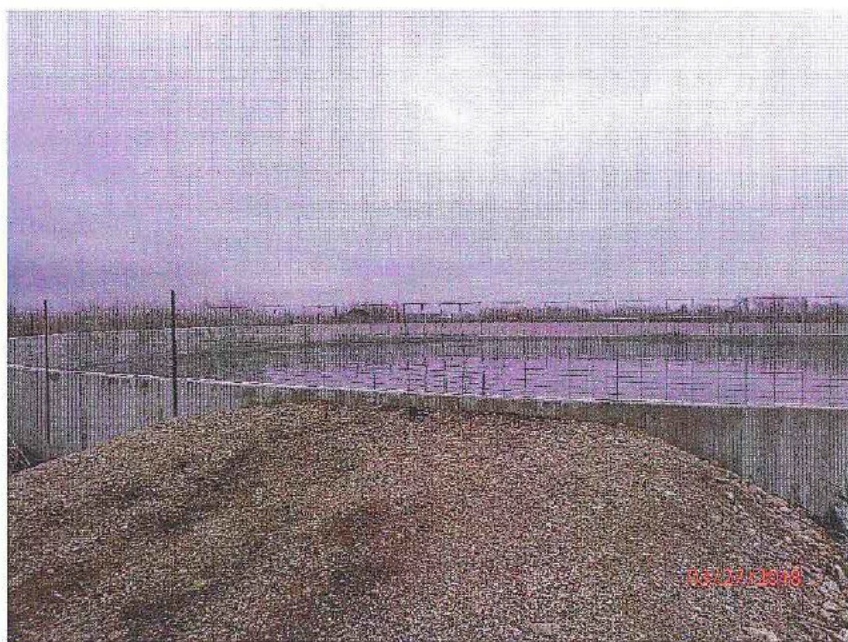
28: P3270044

Description: Solids stay in Old Manure Pond and liquid is pumped to New Manure Pond.

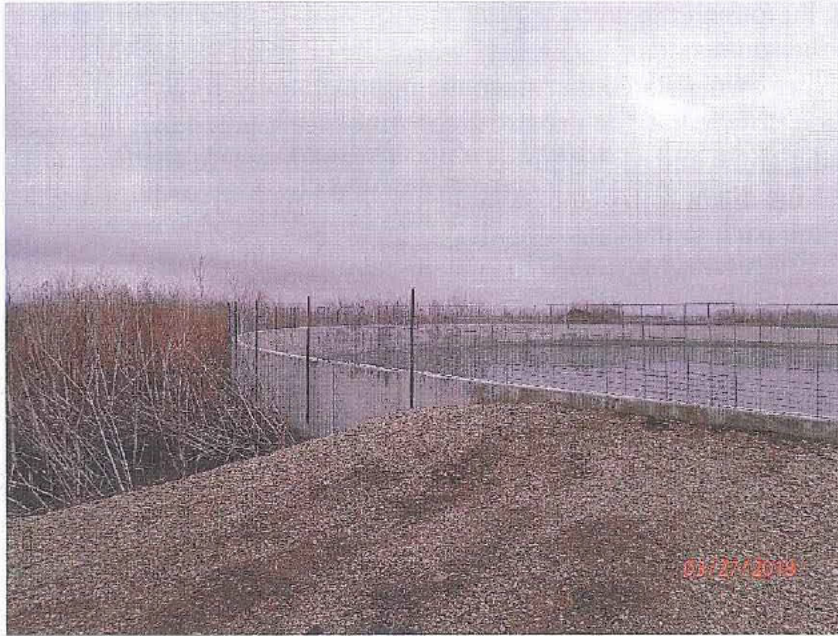
29: P3270045

Description: Liquid from New Manure Pond is land applied.

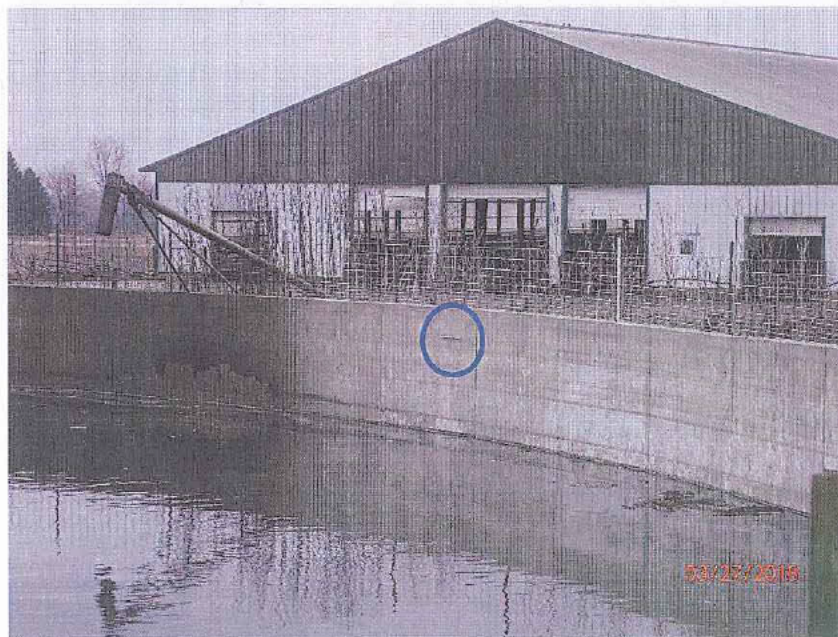
30: P3270046

Description: Margin of safety marker in New Manure Pond is identified with blue circle.

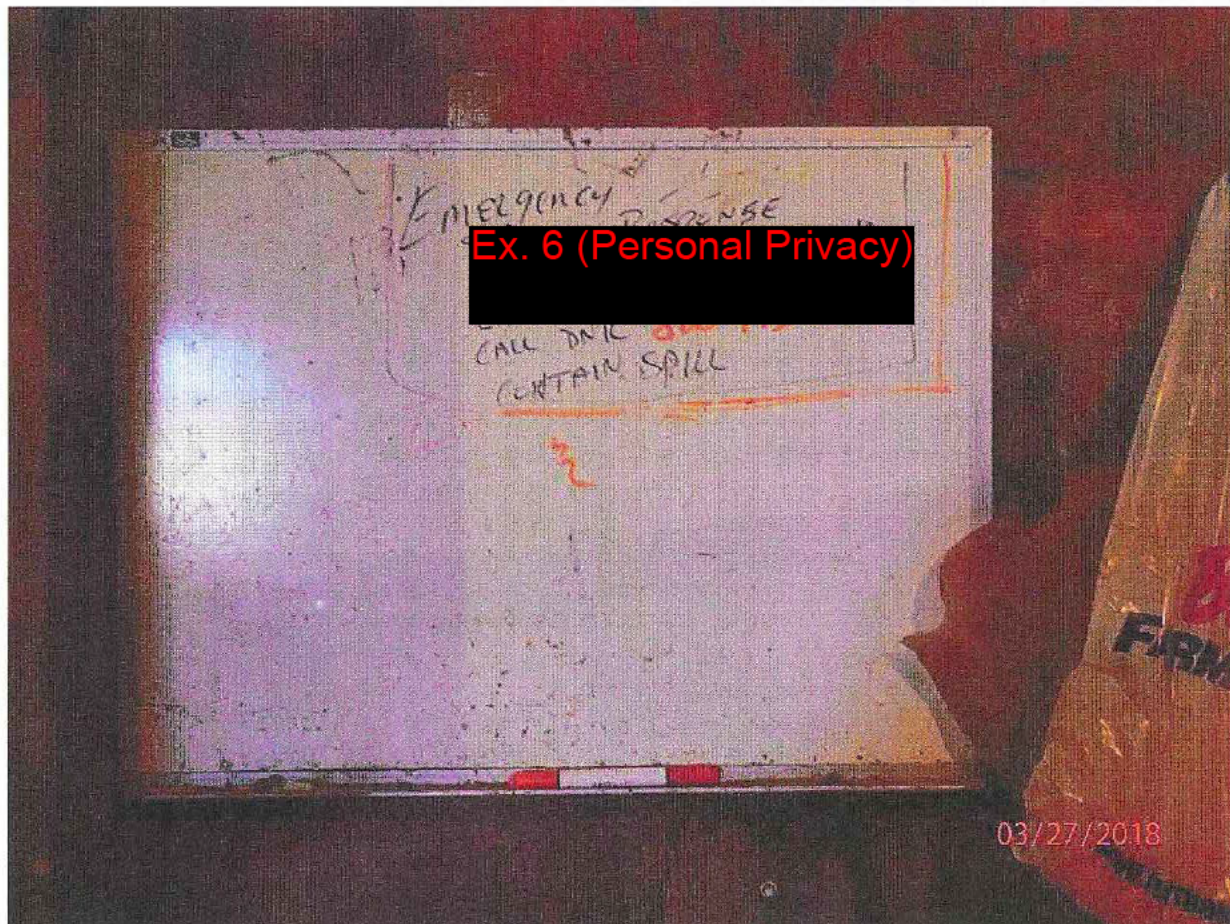
31: P3270047

Description: Emergency spill response numbers on white board in office.

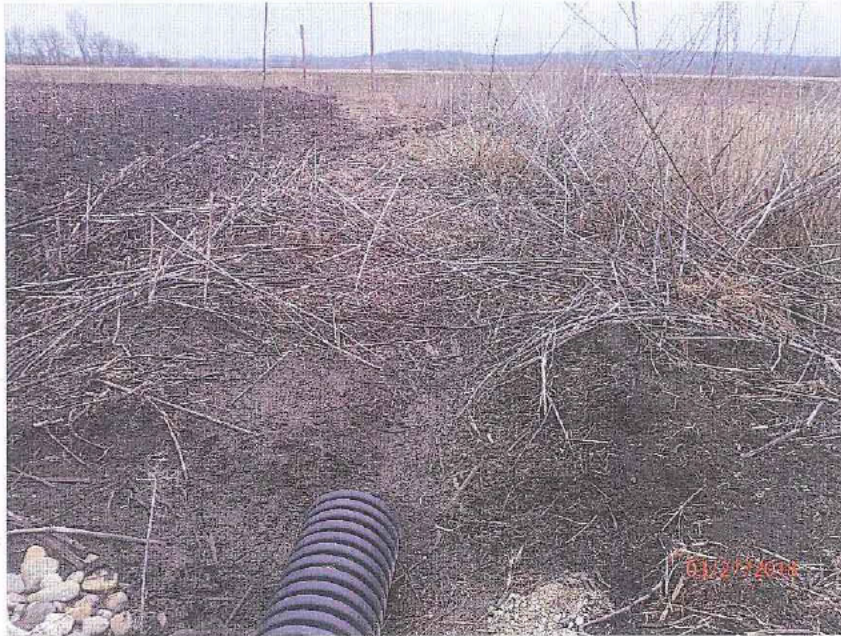
32: P3270048

Description: Storm water ditch on south side of facility has very little flow in it now.
